**OPSB 0166-17R4**

Date: December 13, 2017

To: Operators of Rockwell Collins Flight Management Systems Pro Line 4 and Pro Line 21 FMS 3.3.x through FMS 4.x

Subject: The FMS may turn in the wrong direction after sequencing a “Climb to” altitude that was manually edited or Temperature Compensated

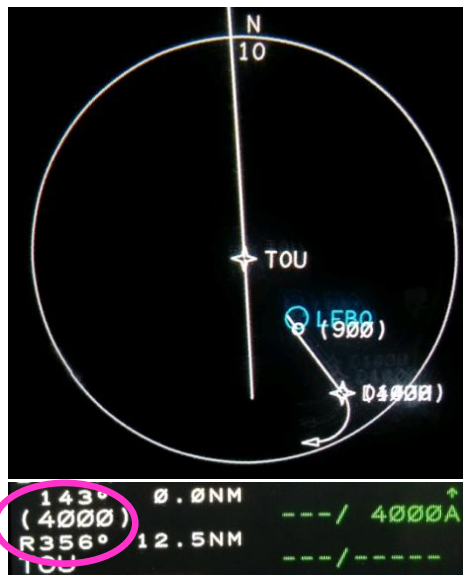
A manual altitude entry immediately removes turn direction on all active FMSs. Figures 3a and 3b show the issue departing LFBO Runway 14L on FIST5A. In Figure 3a, on the LEGS page,

- **“Climb to” altitude of 4000 feet** is identified by the parentheses: **“(4000)”**
- **Turn direction is right**, identified by **“R”** (Right) for the immediately following leg
- Figure 3b shows that after the crew enters 4200A in place of 4000A as the “Climb to” altitude the **“R”** (right) turn direction is removed, as shown on the LEGS page
- The shortest turn is currently computed to be left (instead of right), as shown on the map

Figure 3a. “Climb to 4000 feet followed immediately by Right turn 356° course to TOU.

1. If Temperature Compensation is ON, turn Temperature Compensation OFF, and press EXEC.
2. Reselect the procedure (departure or approach), and press EXEC.
3. Do not again manually edit the “Climb to” altitude, and do not re-activate Temperature Compensation.

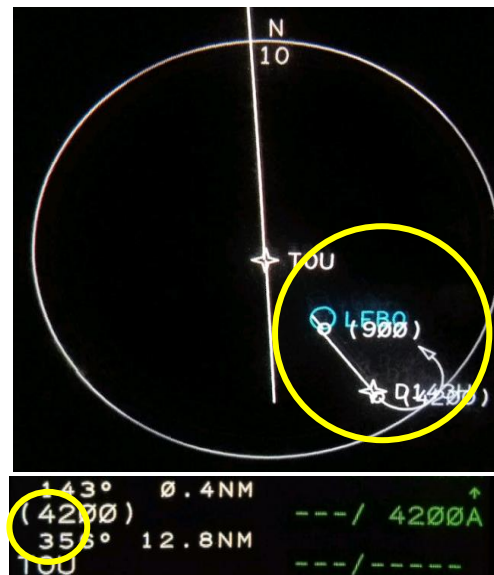
Figure 3b. After manually entering 4200A (in places of 4000A), the “R” turn direction is removed and the FMS computes the shortest turn direction, left in this case.
